**ERBIL POLICE ACADEMY**  
**UNDER THE IRAQ SECURITY FORCES FUND**  
**ERBIL, IRAQ**

**SIGIR PA-07-115**  
**JANUARY 22, 2008**

SUBJECT: Report on Construction of the Erbil Police Academy, Erbil Iraq (Project Number  
SIGIR PA-07-115)

## **Erbil Police Academy Under the Iraq Security Forces Fund Erbil, Iraq**

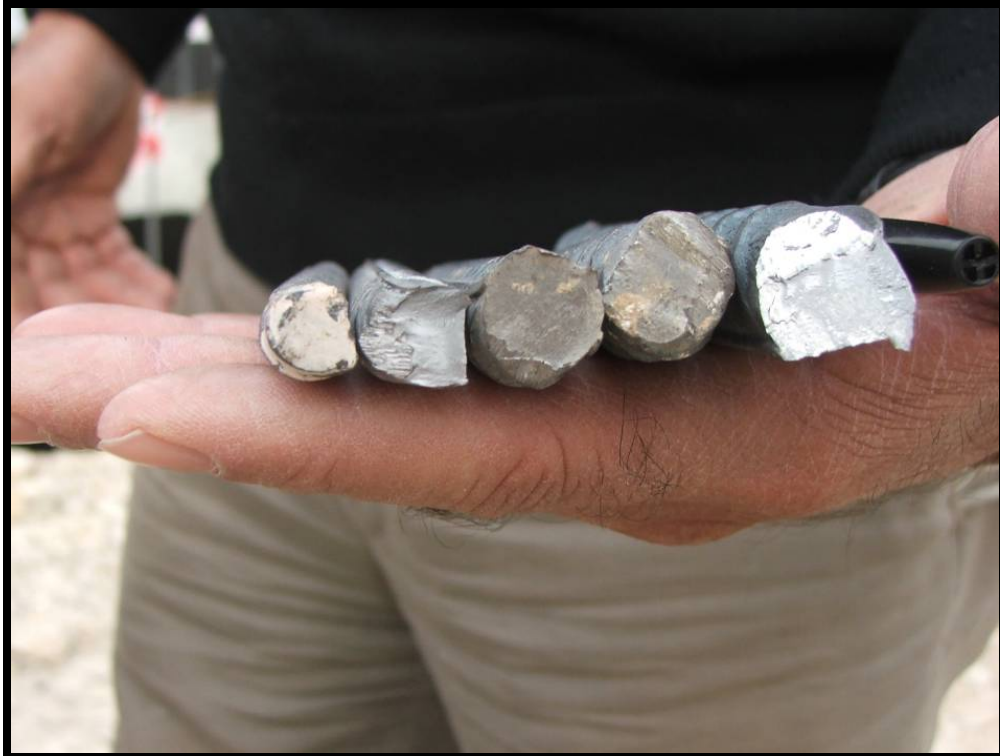
Site Photo 1. Rebar varied between .375" and .675" diameter depending on application.

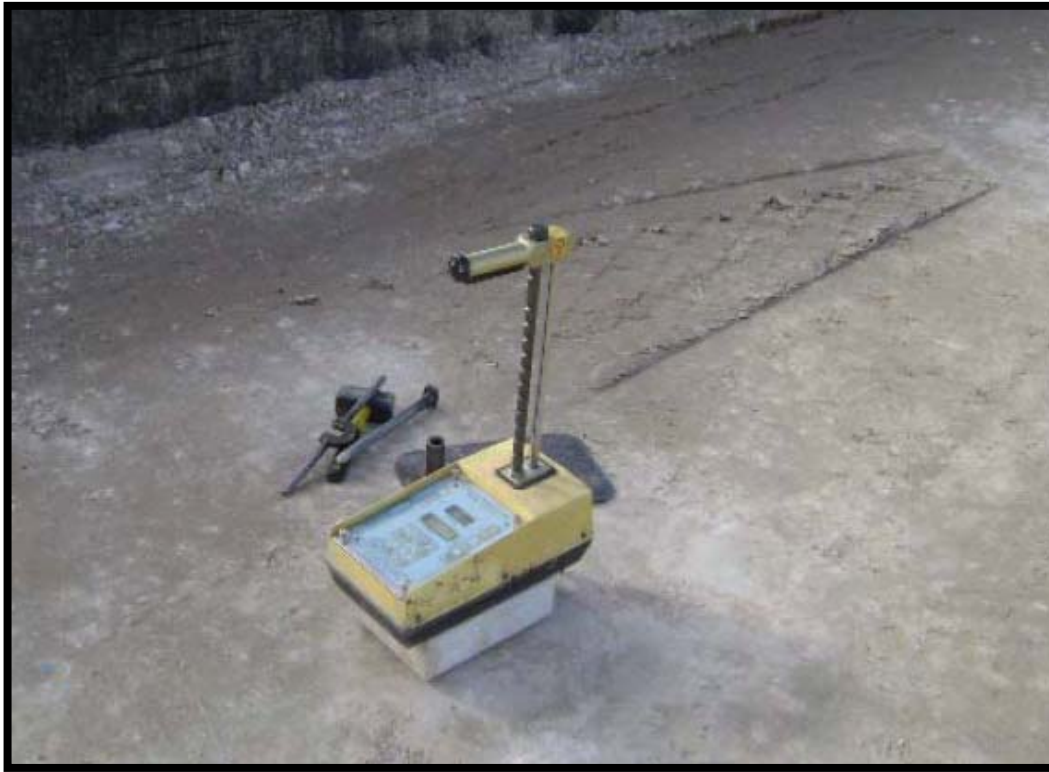
**Site Photo 3. The contractor used modern equipment to perform compaction tests during the process fill and compact in layers. (Contractor provided photo)**

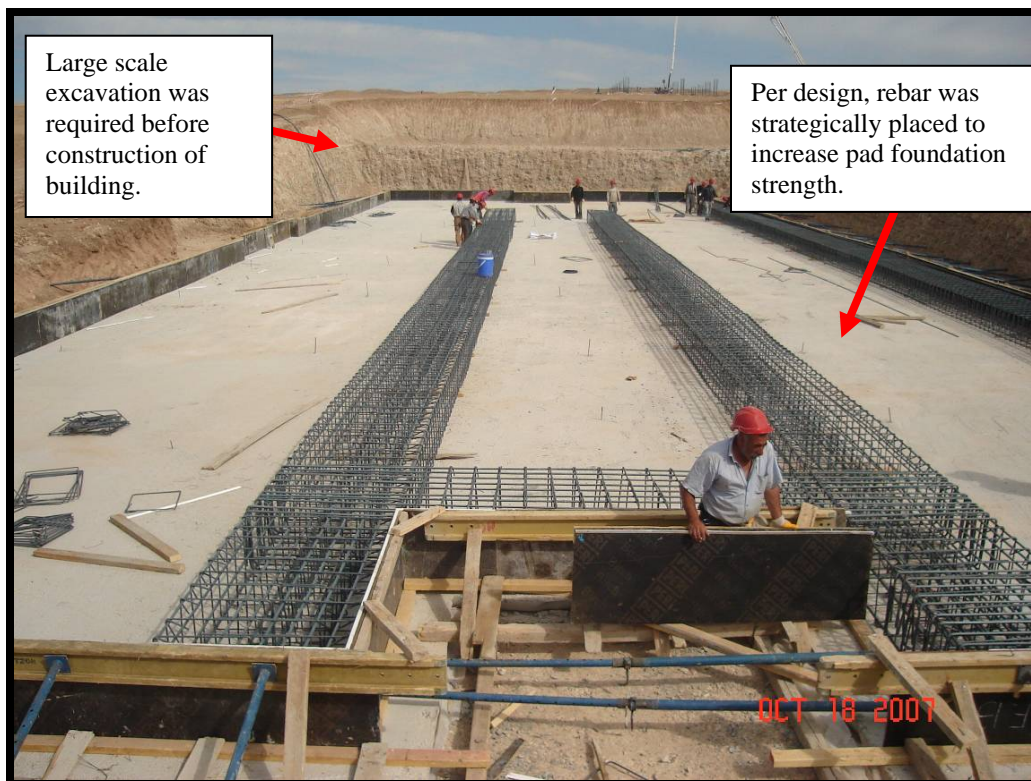
In addition, SIGIR reviewed selected test results and found that concrete strength requirements were met. The RE stated that acceptable mixed concrete was readily available locally. The contractor's 18 November 2007 QC report included Site Photo 3 showing that electronic equipment was used to verify whether soil was sufficiently compacted prior to construction. The 18 November 2007 QC report included a short, but sufficient, narrative about compacting soil work performed for the dormitory building. Site Photo 4 included in QA report dated 18 October 2007 shows a number of things descriptive of the project in general. For example, the size of the education building and the extent of site excavation work can be visualized. The photo documents the proper use of forming materials specified in the Scope of Work and proper placement of rebar over a sub-grade footing in the basement floor to adequately support load bearing walls that are yet to be constructed.

**Site Photo 4. In single-story pad foundations, horizontal rebar assemblies designed to increase foundation strength were placed below the location of planned load bearing walls. (Photo courtesy of USACE)**

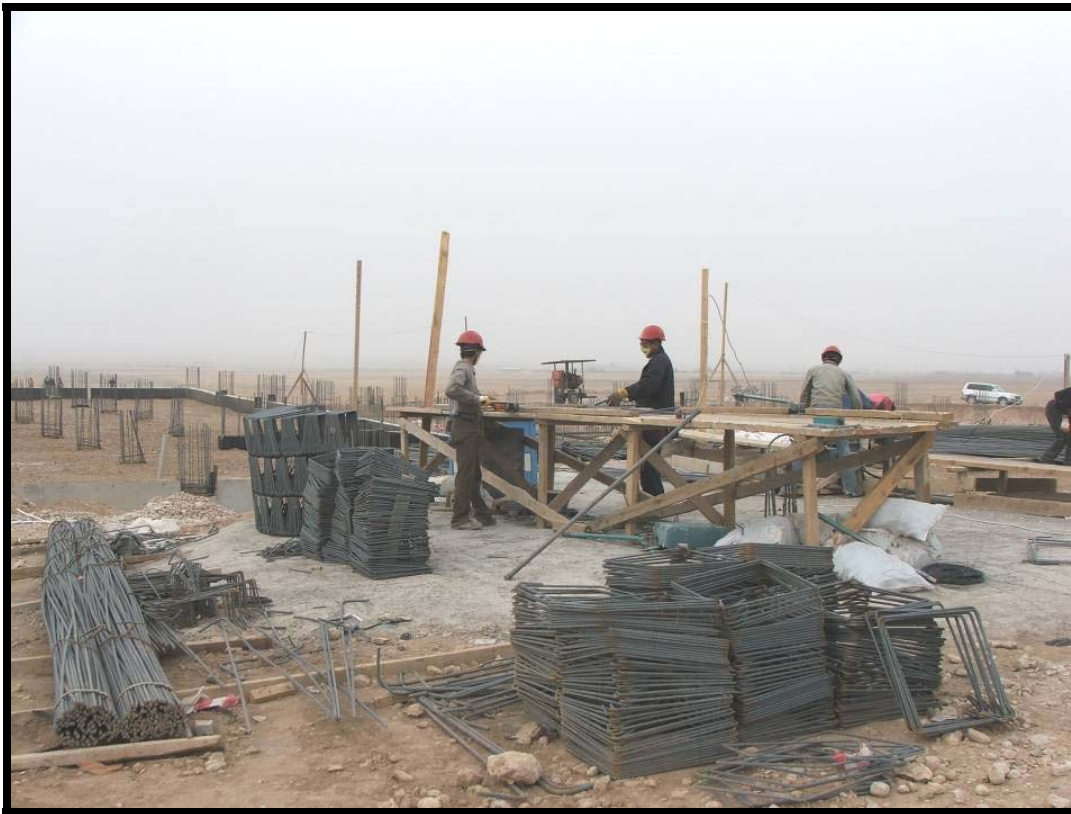
Site Photo 5 shows workers using a bench with cutting and bending equipment to measure, cut, and bend raw rebar stock for subassemblies. Site Photo 6 shows a prefabricated rebar subassembly built in accordance with design requirements. This process to use a designated work area to prefabricate rebar subassemblies should contribute to overall project quality.

**Site Photo 5. Workers used a bench with good equipment to measure, cut and bend rebar assembly sub-components used throughout the project.**

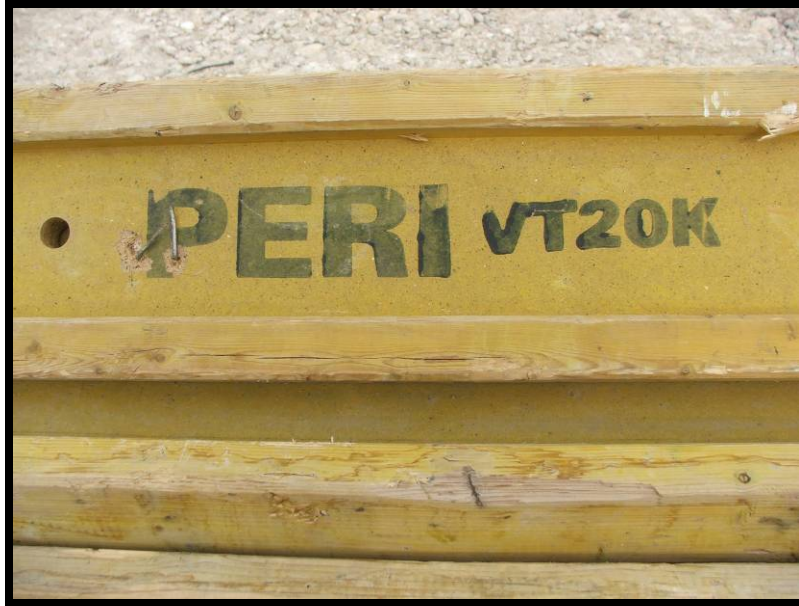
Site Photos 14 and 15 document the contractor use of Peri formwork materials as required. A Peri solid girder is shown in Site Photo 14 and a portion of a sheet of Peri plywood is shown in Site Photo 15. The black resin coating on the plywood ensures a smooth concrete finish because the form will not bond with the concrete. The Peri girder is manufactured to uniform specifications in terms of load capability and dimension. As such, workmen can be assured that the girders will be strong enough when properly placed to ensure a flat concrete floor/ceiling when used in combination with Peri plywood specifically designed for formwork applications. The contractor's on-site engineer stated that workers liked to use Peri formwork materials compared to non-uniform materials because their uniformity made it easier to build proper forms.

**Site Photo 14. Per Scope of Work, a manufactured form girder system was used.**

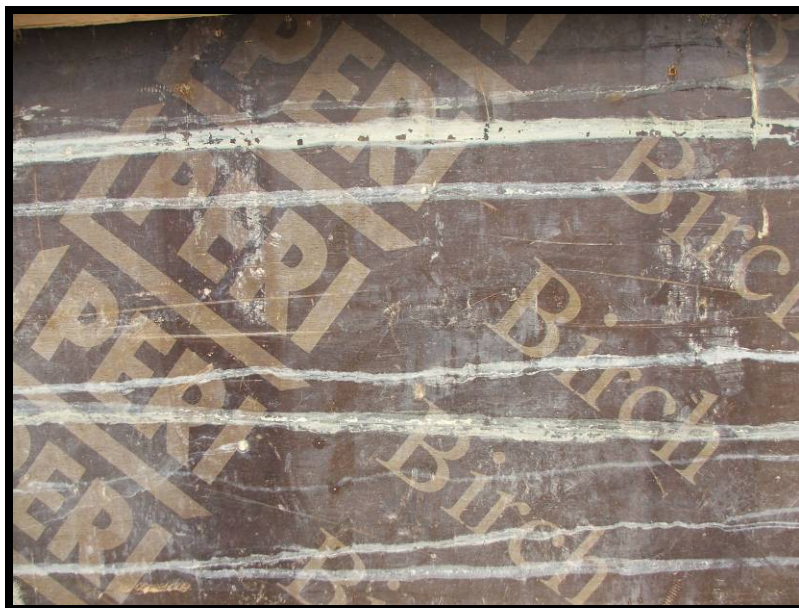
**Site Photo 15. Contractor used premium forming materials.**

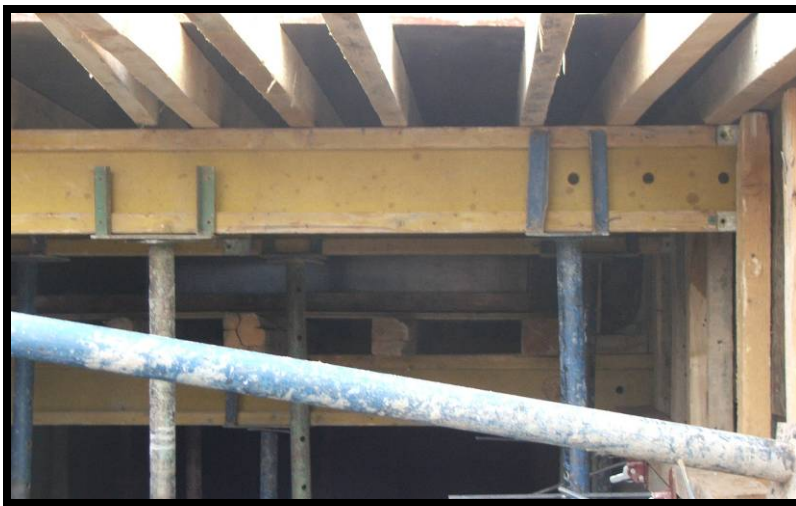
Site Photos 16 and 17 are of the dormitory basement. In Site Photo 16, an advantage of a system of uniform forming materials is demonstrated. Specifically, a Peri girder securely lies horizontally flat and vertically upright atop the steel post that can be locked at the required height. Because this portion of the work was still in progress, short section beams and plywood were not yet properly placed.

**Site Photo 16. Throughout facility, form work was excellent.**

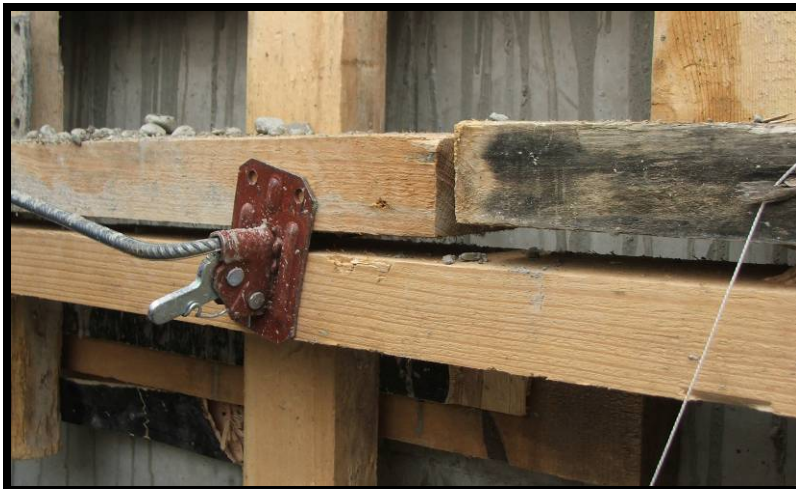
As previously stated, all horizontal and vertical edges observed were straight and the thickness of poured concrete walls was uniform. Contrary to formwork methods that rely on non-uniform materials, substantial nailing or spacers with tie wires, the contractor used a system of locks to ensure that column and vertical walls were uniform. Site Photo 17 shows a close-up of such a lock. As concrete fills a form, the form is retained in proper position by a lock on either side of the form. Prior to pouring concrete, workers simply measure the correct dimension of the form, places a piece of rebar through the form, and lock the desired position.

**Site Photo 17. Locks effectively controlled form movement during casting.**

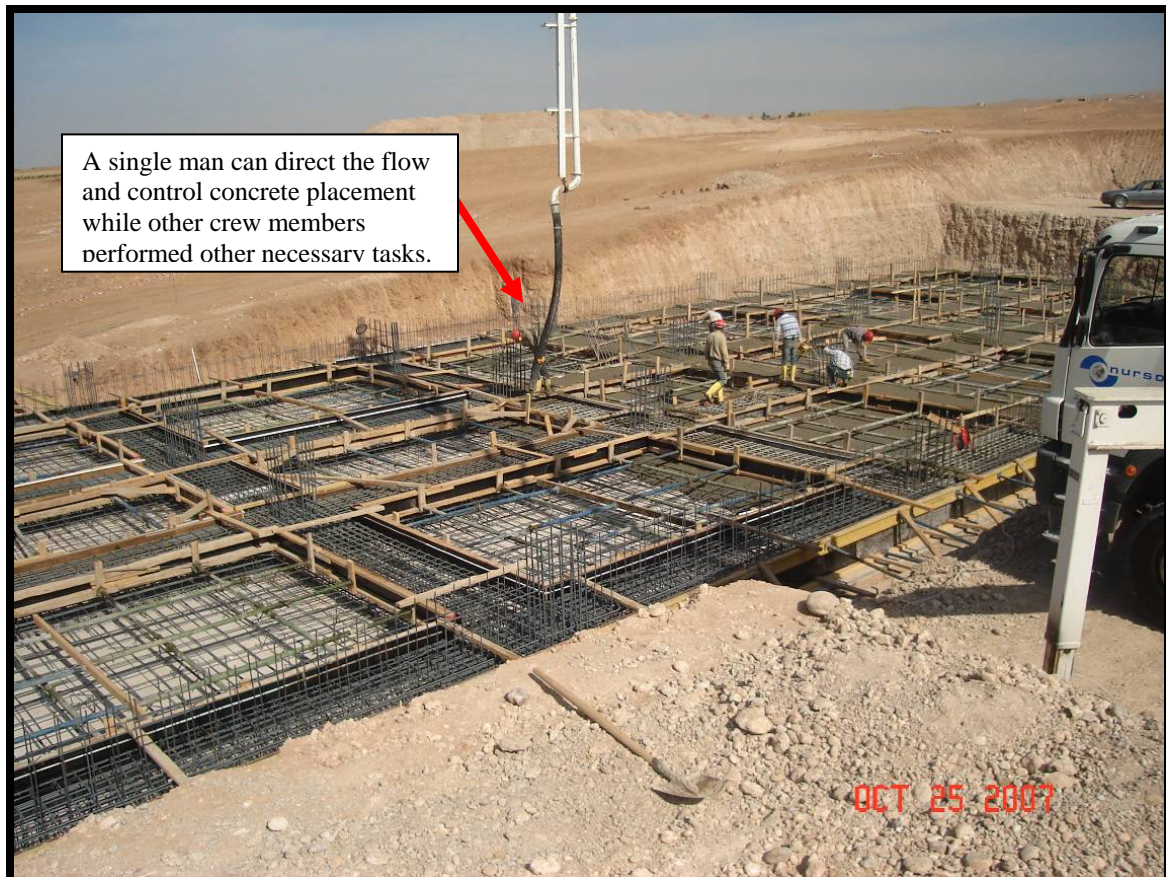
The RE stated that a concrete pump with an extension boom had been used to place concrete throughout the project. Such equipment facilitates placing concrete in a continuous manner resulting in normal and uniform shrinkage during the cure process. In

addition, this practice to place concrete avoids dropping the concrete too far and minimizes separation of the concrete mix materials (water, rock and cement). When properly vibrated during the casting process honeycombing is also avoided. As a result, uniform concrete strength is ensured. In additions to being faster than using more labor intensive methods (wheel barrows or buckets) to place concrete, worker safety and form maintenance is improved because the extension boom can reach any part of the project from a correctly positioned pump. The RE stated that the contractor used the services of fully capable ready-mix concrete suppliers and had backup pump equipment. Site Photo 18 shows the reach of the pump's extension boom.

**Site Photo 18. Concrete pump extension boom used to place concrete was handled by one man.**  
(Photo provided by USACE)

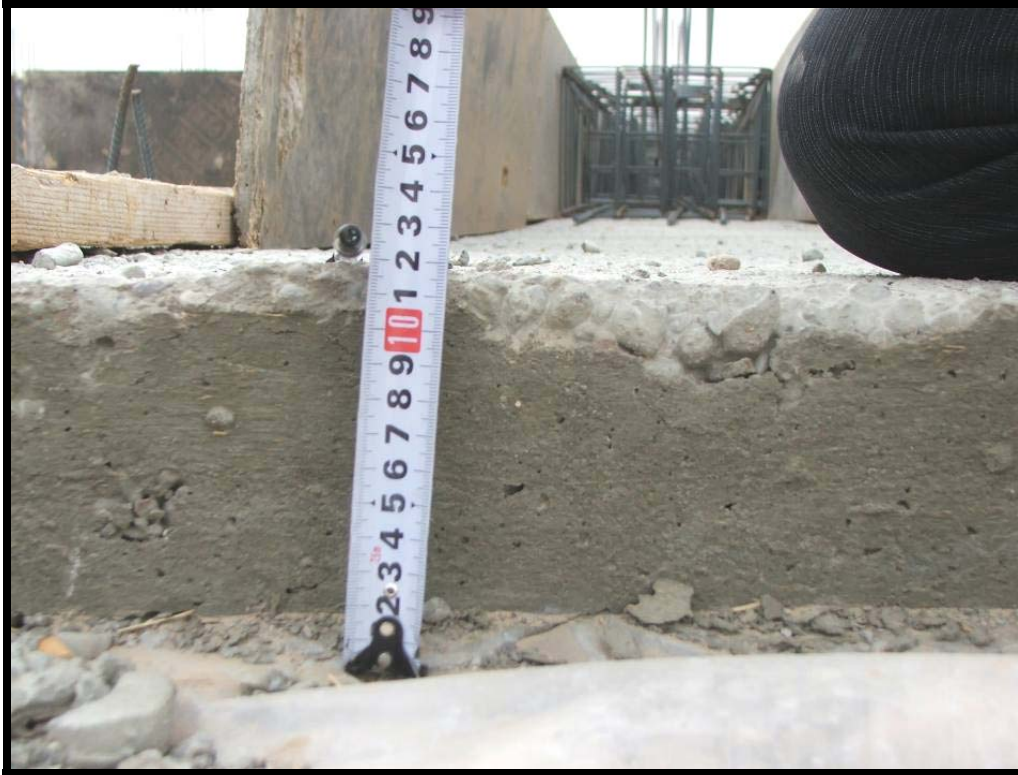
The Scope of Work required the contractor to supply materials and cast lean concrete (class C16<sup>7</sup>) under foundations. The lean concrete was required to be 10 centimeters or approximately 3.9 inches thick and placed to meet the required elevations of the structural foundation. As shown in Site Photo 19, the lean concrete was poured to meet required thickness.

Site Photo 19. Blind (lean non-structural) concrete was sufficiently thick throughout facility.
